Figure 3.6-10
Open Pit cross-section
Thompson Creek Mine EIS

Figure 3.6-15 TSF, water quality monitoring locations Thompson Creek Mine EIS

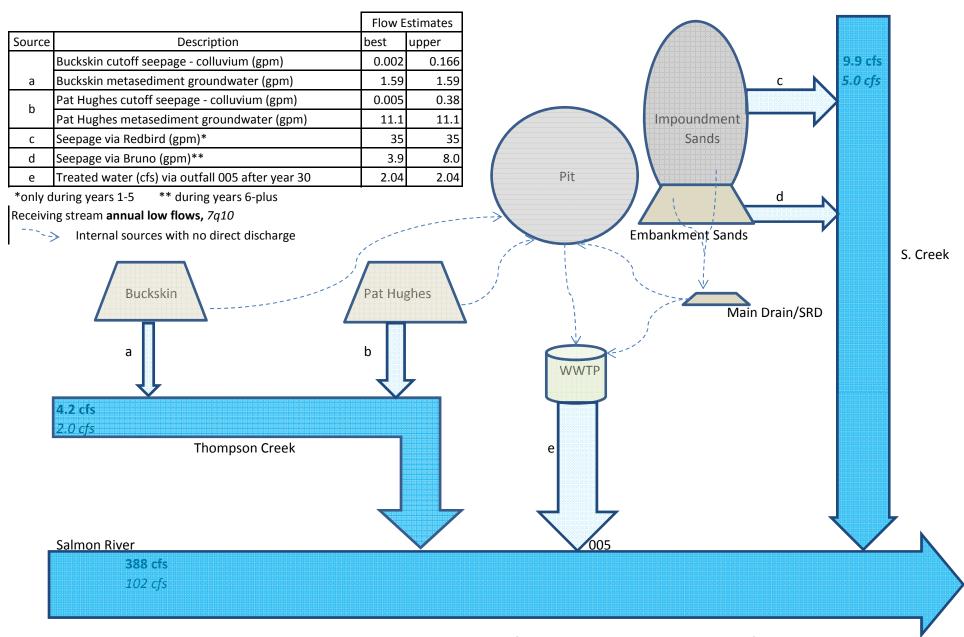
Figure 4.6-1. Alternative M1 reclamation source term fluxes and receiving water flows.

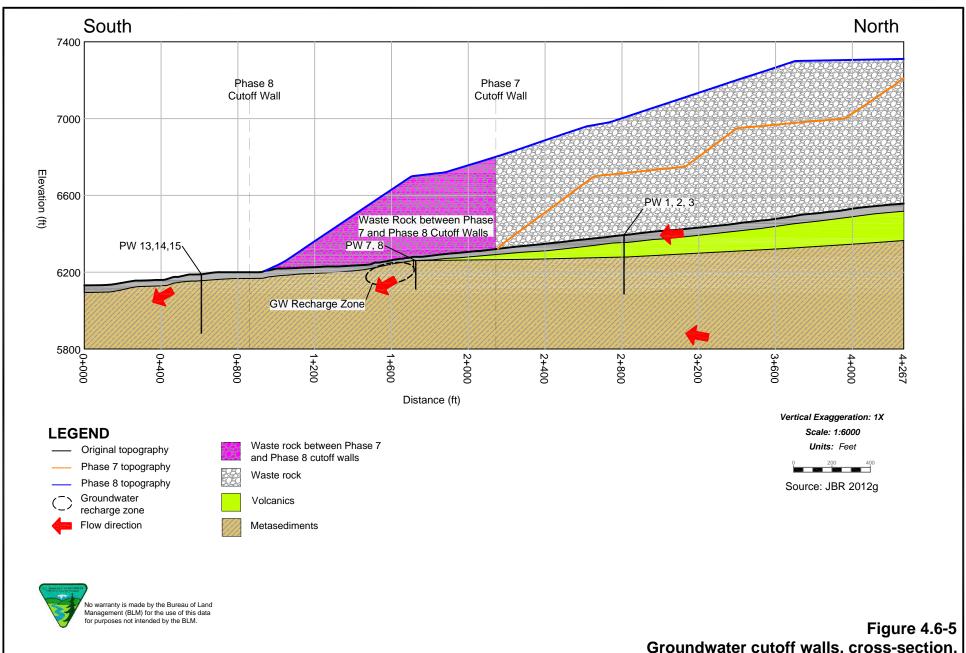
Figure 4.6-5
Groundwater cutoff walls, cross-section,
Pat Hughes Creek watershed
Thompson Creek Mine EIS

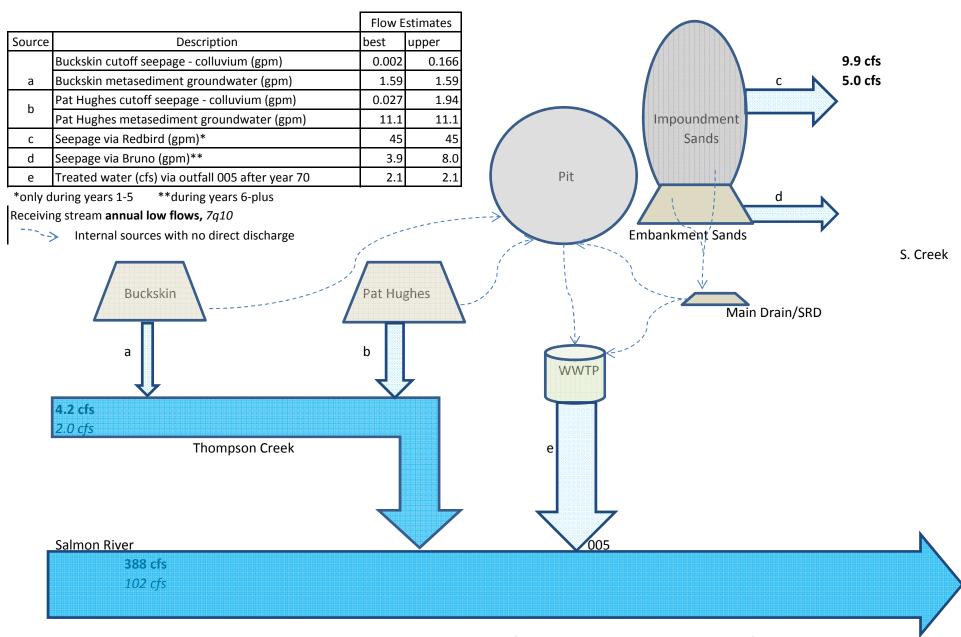
Figure 4.6-6. Alternative M2 reclamation source term fluxes and receiving water flows.

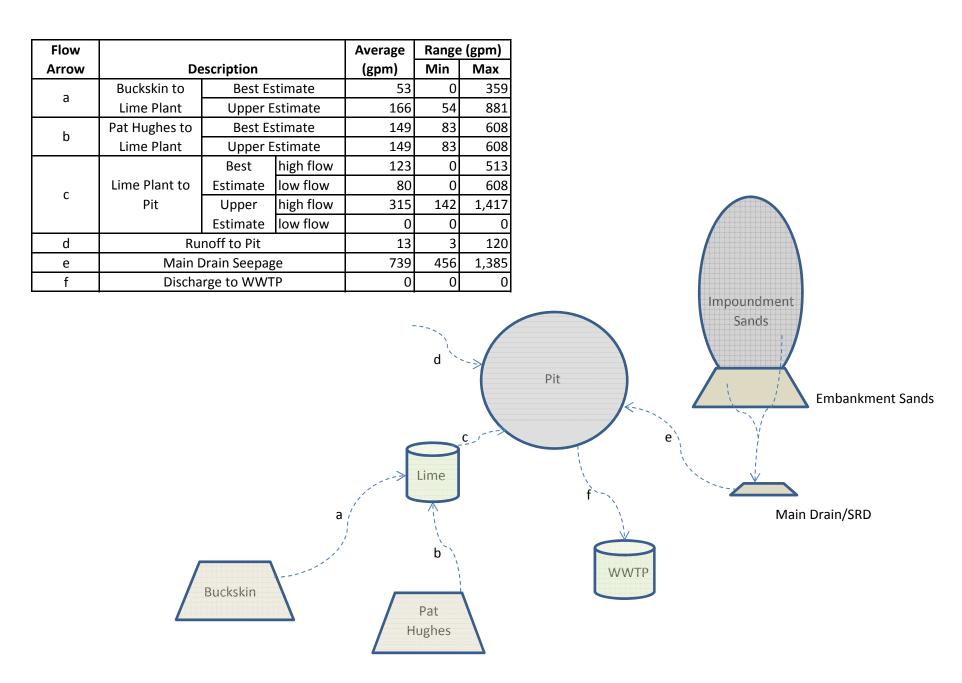
Figure 4.6-7. Alternative M2 water management, years 1-5.

Flow Arrow		escription		Average	Range	lanml	
		escription		1		(gpm)	
_	h	D		(gpm)	Min	Max	
a	Buckskin to		stimate	51	0		
	Lime Plant		stimate	219	45	1,497	
b	Pat Hughes to		stimate	239	70		
	Lime Plant		estimate	239	70		
	Linna Dlanetta	Best	high flow	128			
С	Lime Plant to	Estimate	low flow	150	0		
	Pit	Upper	high flow	440	120	3,069	
		Estimate	low flow	0	0		
d		Runoff to Pit		36	3		
e		Orain Seepag	145		45 522		
f	Discharge to	wwiP from	rear 28	655	U	15,523	Impoundment
		Buckskin	a		Lime	C	Embankment Sand Main Drain/SRD
